## Influence of damage during installation on the tensile strength of asphalt reinforcement products

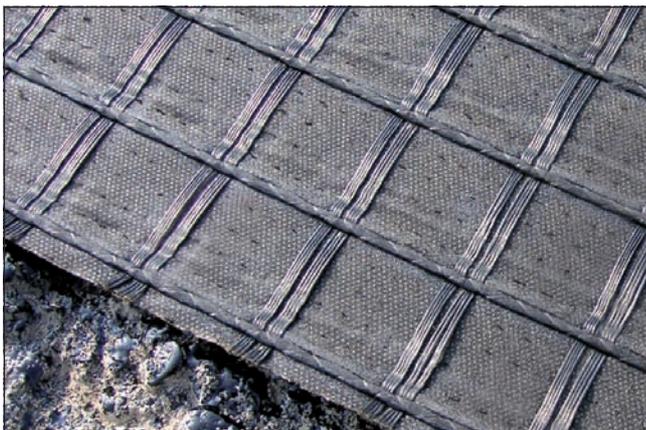
Fig. 1.: Asphalt reinforcement HaTelit® C 40/17

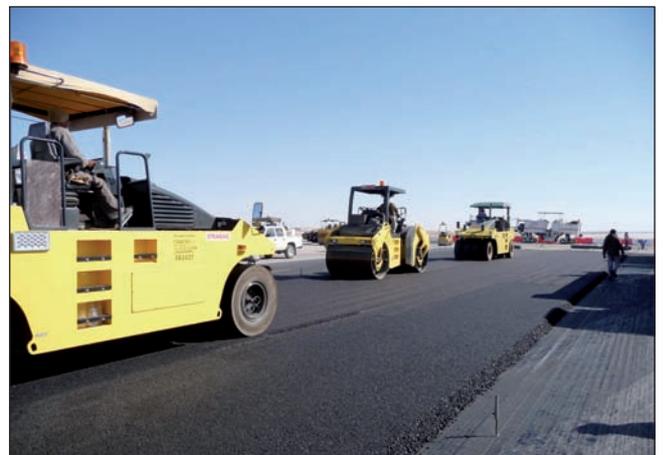
Fig. 2.: Influences on asphalt reinforcement

The properties of asphalt reinforcement (e.g. tensile strength, tensile strain) are influenced during their installation, the paving procedure (paver and truck passes) and the compaction of the asphalt (Figure 2).

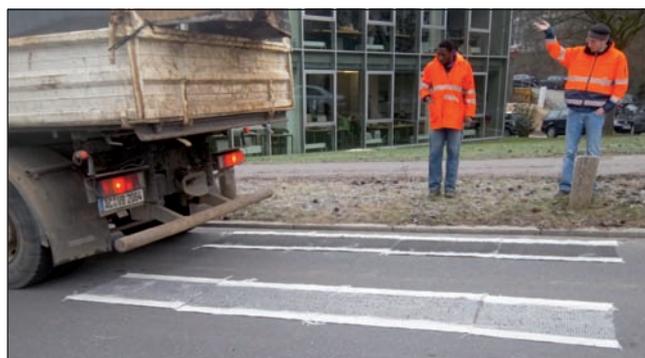
Fig. 3.: Influences on the installation of asphalt reinforcement products

carried out by 35 passes of a 2-axes truck (forward and backward) with a speed of  $20 \pm 5$  km/h without any steering movements or breaking activity (Figure 3). Considering a typical asphalt delivery truck with 5 axes, this corresponds to 7 passes of a truck on site.

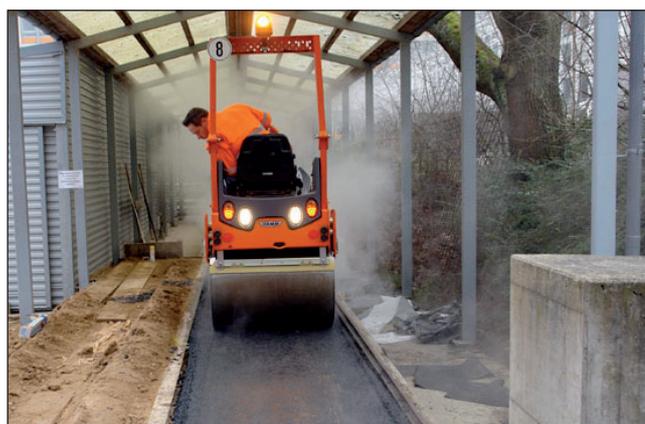
Fig. 4.: Asphalt installation and compaction

In preparation for the tests, an asphalt binder course (AC 16 B S) was installed on the base of the test track first. Onto the binder course, the reinforcement grids have been placed according to the manufacturer's installation guidelines. Some of the predamaged specimen (truck passes) have also been used in the test-track for further exposure to simulate the double load-effect, truck passes and compaction. To differ between undamaged, predamaged and the different loading types, the specimen had been placed into separate sections. Subsequent to the installation of the reinforcement specimen a 50 mm asphalt wearing course was installed and compacted with 6 roller passes (2 static and 4 dynamic) (Figure 4).

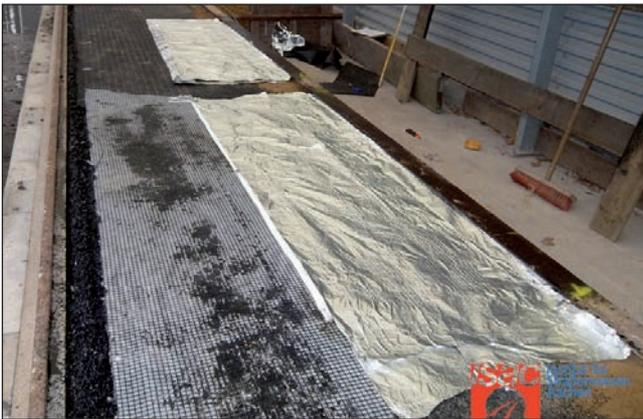
Fig. 5.: Placed products.

Right: Wrapped in foil with separating agent

To test their tensile strength after the asphalt installation and compaction, some of the specimen had to be removed close after the installation of the wearing course. For this reason these specimen have been wrapped into an aluminium foil and coated with a separating agent to create a very bad interlayer bond (Figure 5 and 6).

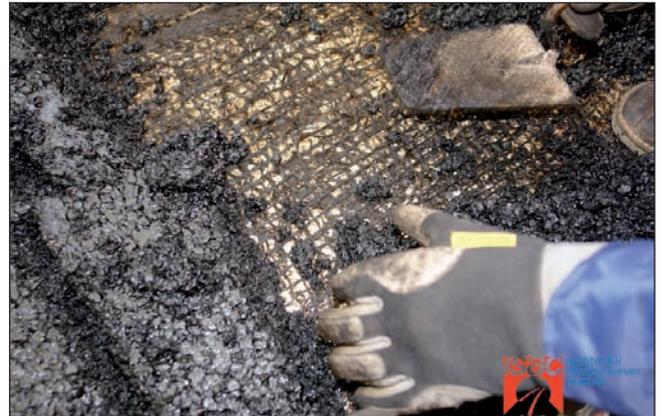
Figure 6. Uncovering the products

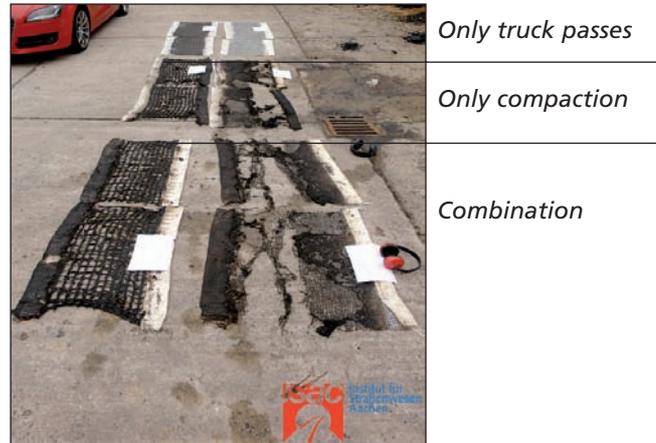
Figure 7.: Results of installation damage test  
Left: PET-Grid; Right: Glass-fibre grid

The Polyester-grid (HaTelit®) specimen which were loaded by the asphalt compaction and the truck passes still had a residual strength of 70% whilst the Glass-fibre grid revealed further damage with a residual strength of 11% only (of the measurable areas, see Figure 7).

The results revealed the considerable difference of the influence from truck traffic and asphalt compaction on the tensile strength of the specimen. For this it must be mentioned, that for the damaged glass-fibre grids the test samples had to be taken from the side of the specimen, as the middle parts had been completely destroyed during the installation damage test and therefore have been impossible to test (Figure 7).
